Corrective maintenance of ammonia leakage treatment at Sabroe Chiller Evaporator

Engineer. Mabrok dau naily

College of Engineering Technology Janzour

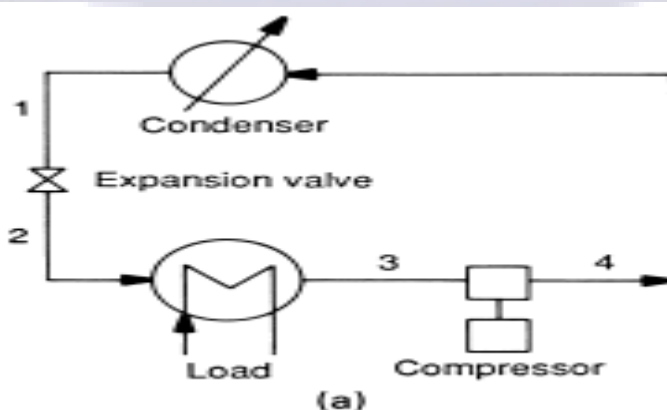
FIGURE 1(a)

A basic circuit of vapor compression refrigeration is in Figure 1(a). After compression, vapor is condensed with water cooling and then expanded to a low temperature through a valve in which the process is essentially at constant enthalpy. In large scale installations or when the objective is liquefaction of the ‘permanent’ gases, expansion to lower temperatures is achieved in turbo-expanders from which power is recovered; such expansions are approximately isentropic. The process with expansion through a valve is represented on a pressure–enthalpy

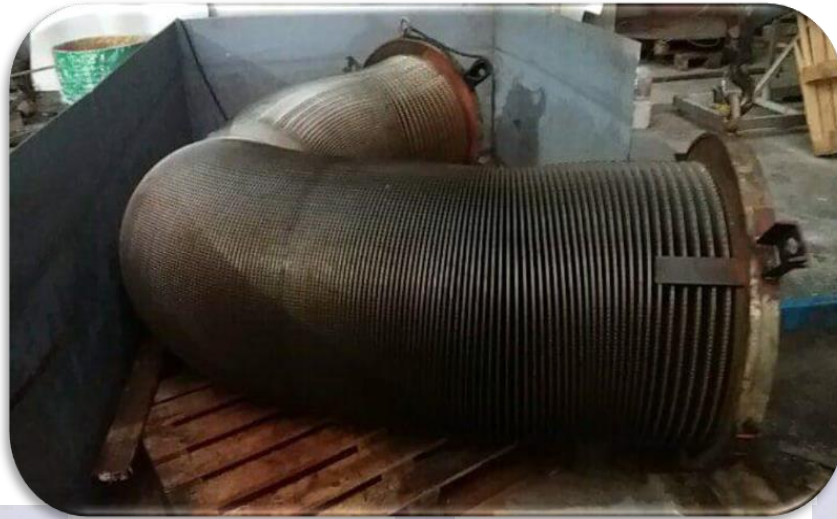
FIGURE No (2) - The destructive evaporator

- 1- Pressure test leads to defected part of internal exchanger.
- 2- A small parts of metal was found inside the evaporator area.

It could be reason of the problem.

- 1- Removed the defected part of exchanger area.
- 2- Reconnect the exchanger then testing it under 20 bar pressure (for 2days) to detect any probable leakage.

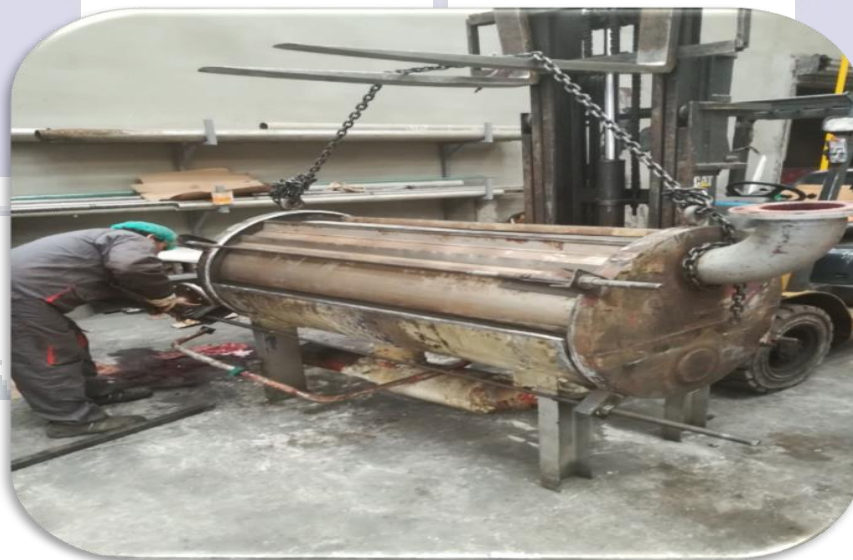
FIGURE No (3) - Reinstalling the evaporator in its pressure case

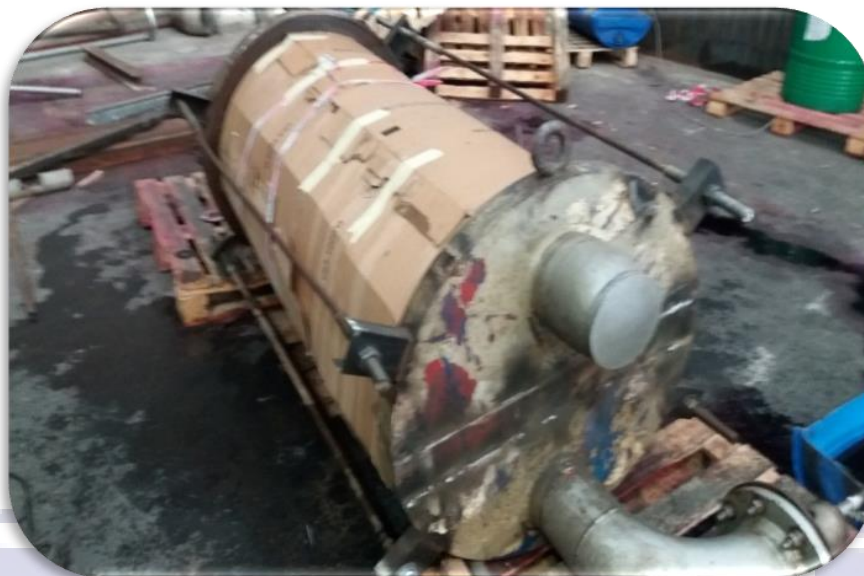
FIGURE No (4) - Isolate the evaporator area against the cutting

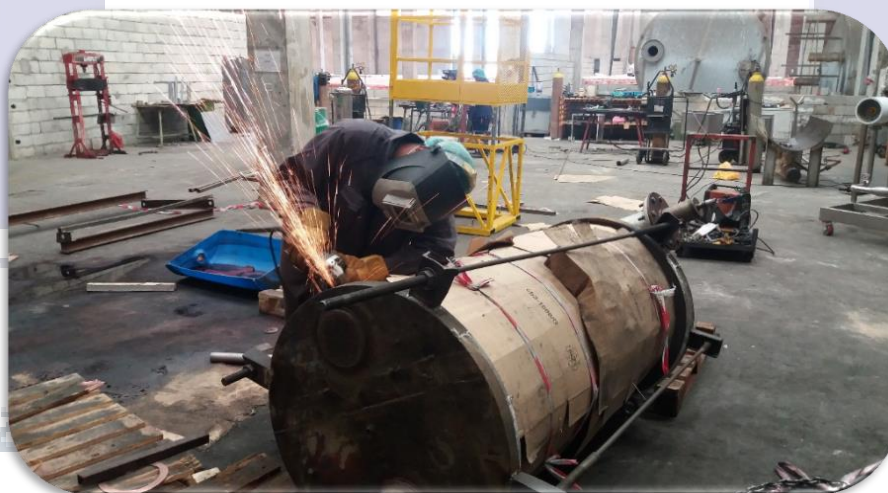
FIGURE No (5) - Remove the modification (treaded bar – nut)

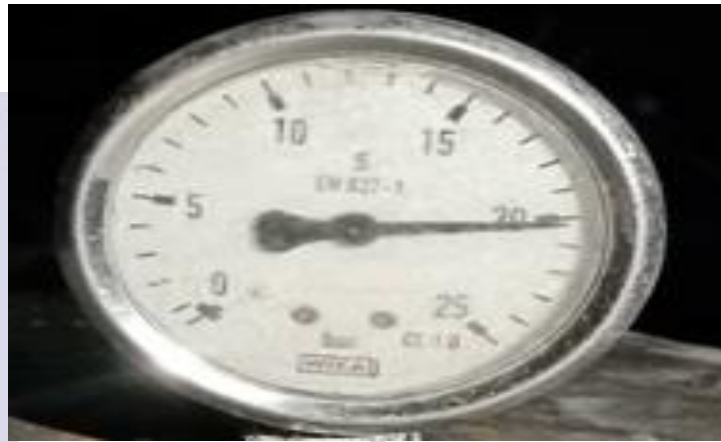
FIGURE No (6) - Pressure test 20 bar

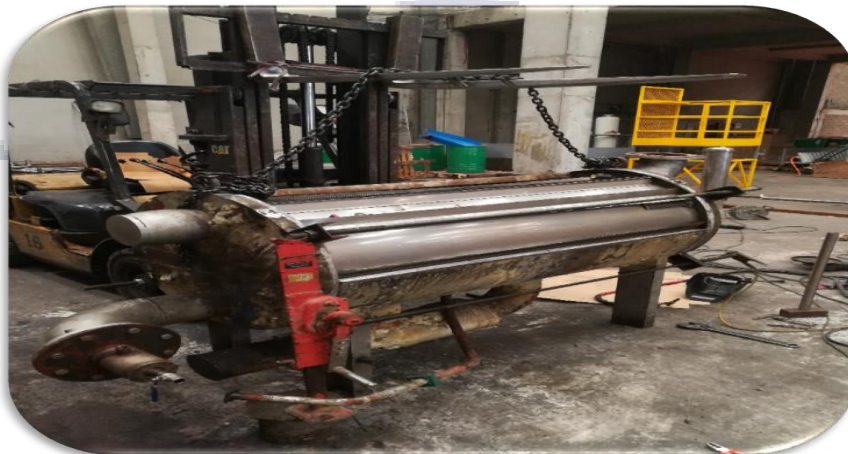
- 3- The evaporator placed on its case.

FIGURE No (7)- Placing exchanger its case

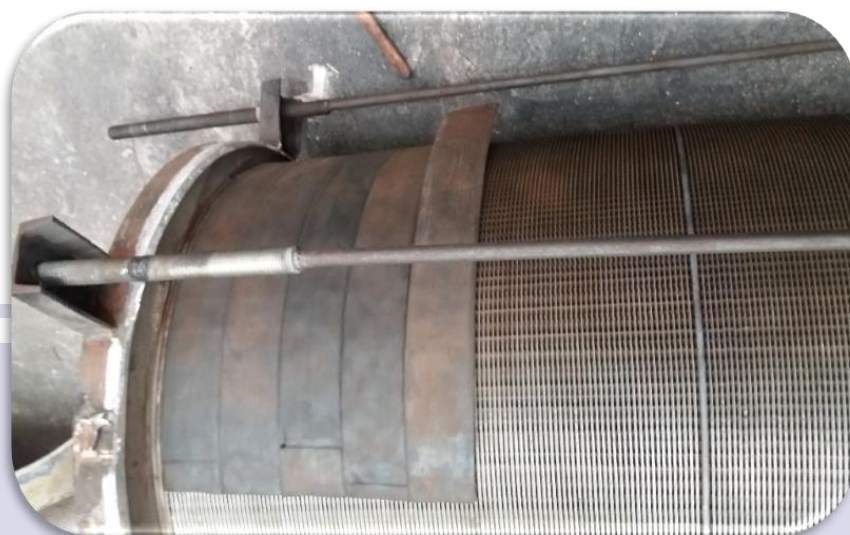
- 4- Covered the exchanger with its jacket.

FIGURE No (8)- Recovering exchanger with its jacke

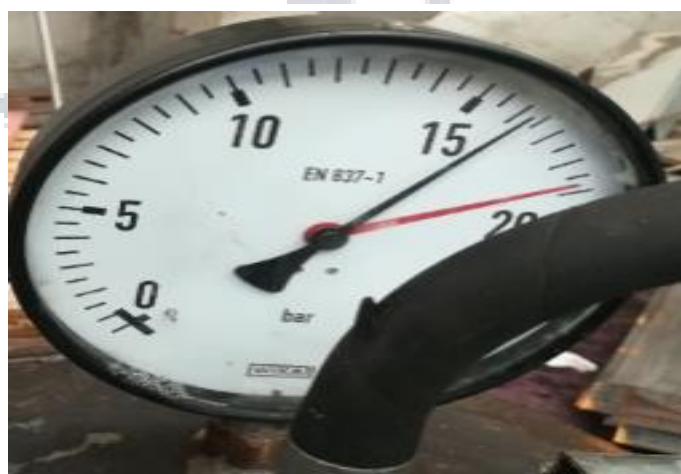
- 5- The Blue dye has been used for leakage test later.
6- Tested under 16 bar (for 48 hrs.) as running pressure test while it is running on suction pressure 4 bar.

FIGURE No (9) - Pressure test 16 bar

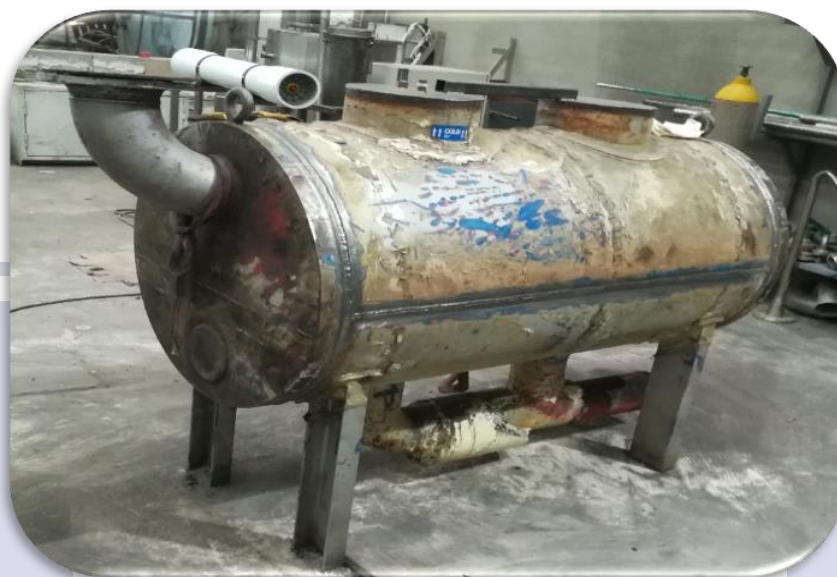
- 7- The case filled with water during outside welding to protect the exchanger rubber jacket from welding heat.
- 8- Strengthen the welding area by using two flat metal bars.

FIGURE No (10) - Assembly the evaporator inside its case

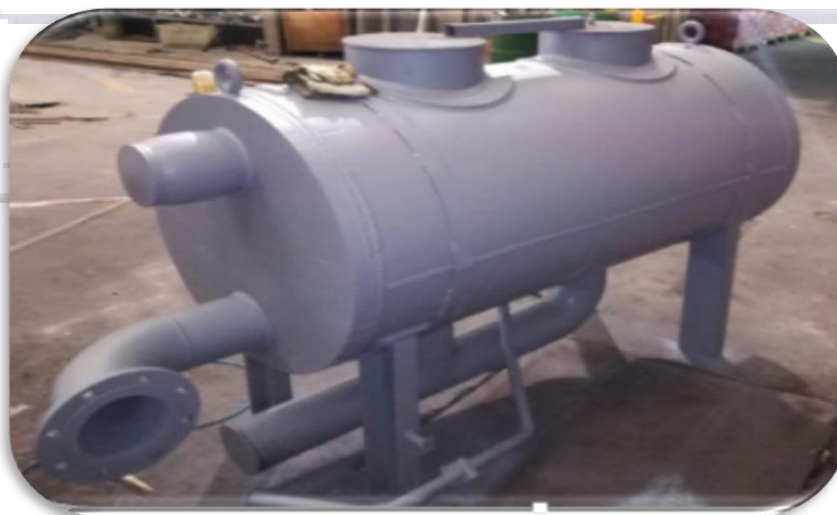
- 9- Repaint the outside area with anti-rust primary.

FIGURE No (11) - Repainting evaporator case

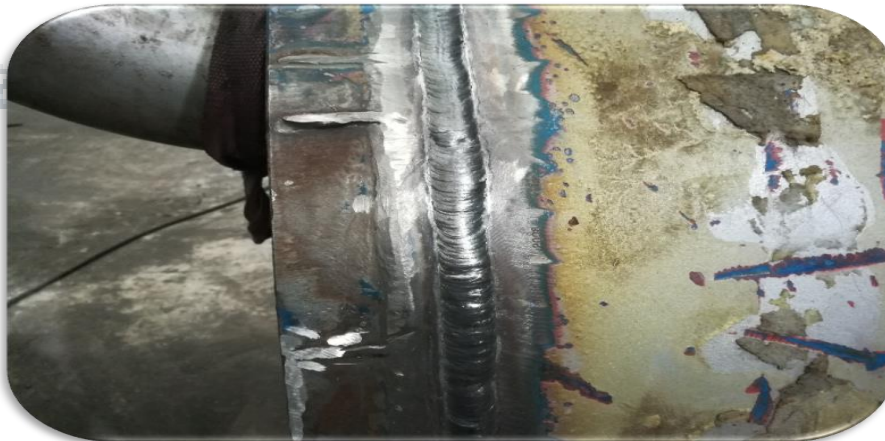
5- Welding groove width was 1.5 cm with 45° degree groove.

FIGURE No (12) - Plate grooving

FIGURE No (13) - Plate grooving

- 3- Preheating done for welding area. (Anti shrinking and minimize the Heat Effected zone. HEZ)

4- Electrode heated up for 1.5 hrs. As part of humidity release.

Electrodes must be baked for 1 hour at 100-120°C before welding

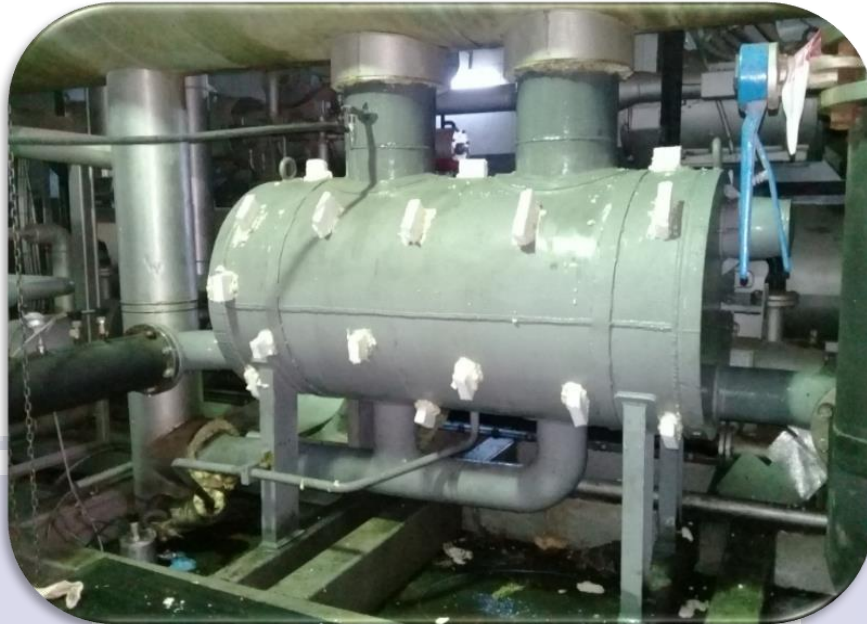
FIGURE No (14) - Re-isolate the evaporator body (cover supporting)

FIGURE No (15) - the evaporator body (cover supporting)

- 1- Fabricate a foam support placed under isolation cover.
- 2- PU FOAM (Cold Surface isolator) has been used as a glue.
- 3- Each support width was 6 cm according to another evaporator isolation, were the calibrator used to detect the isolation layer thickness.
- 4- The support will be rigid by tomorrow, so giving chance for foam to dry
